## CHARACTERIZATION OF MULTIAXIAL WARP KNIT COMPOSITES

H. Benson Dexter  
NASA Langley Research Center  
Hampton, Virginia

### INTRODUCTION

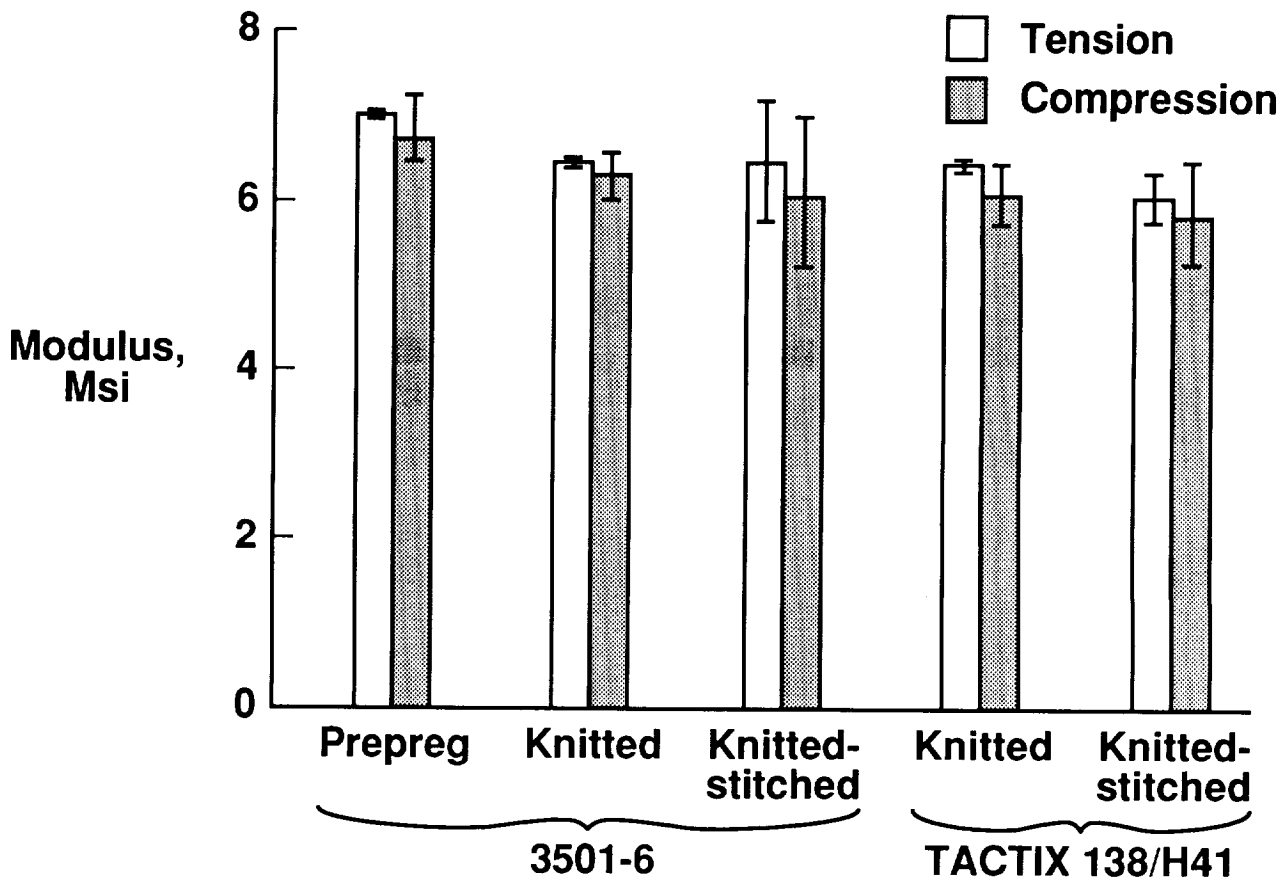
Figure 20

Tensile and compression modulus data are presented in figure 20 for the Hexcel Hi-Tech fabric. The tensile modulus is slightly higher than the compression modulus for all the materials indicated in the figure. The moduli for the knitted and knitted-stitched fabrics are slightly lower than the corresponding moduli for the prepreg tape laminates. These results are expected since the through-the-thickness knitting and stitching yarns do not contribute to the in-plane material properties. In-plane fiber crimp could also lead to reduced in-plane moduli for the knitted and knitted-stitched composites.

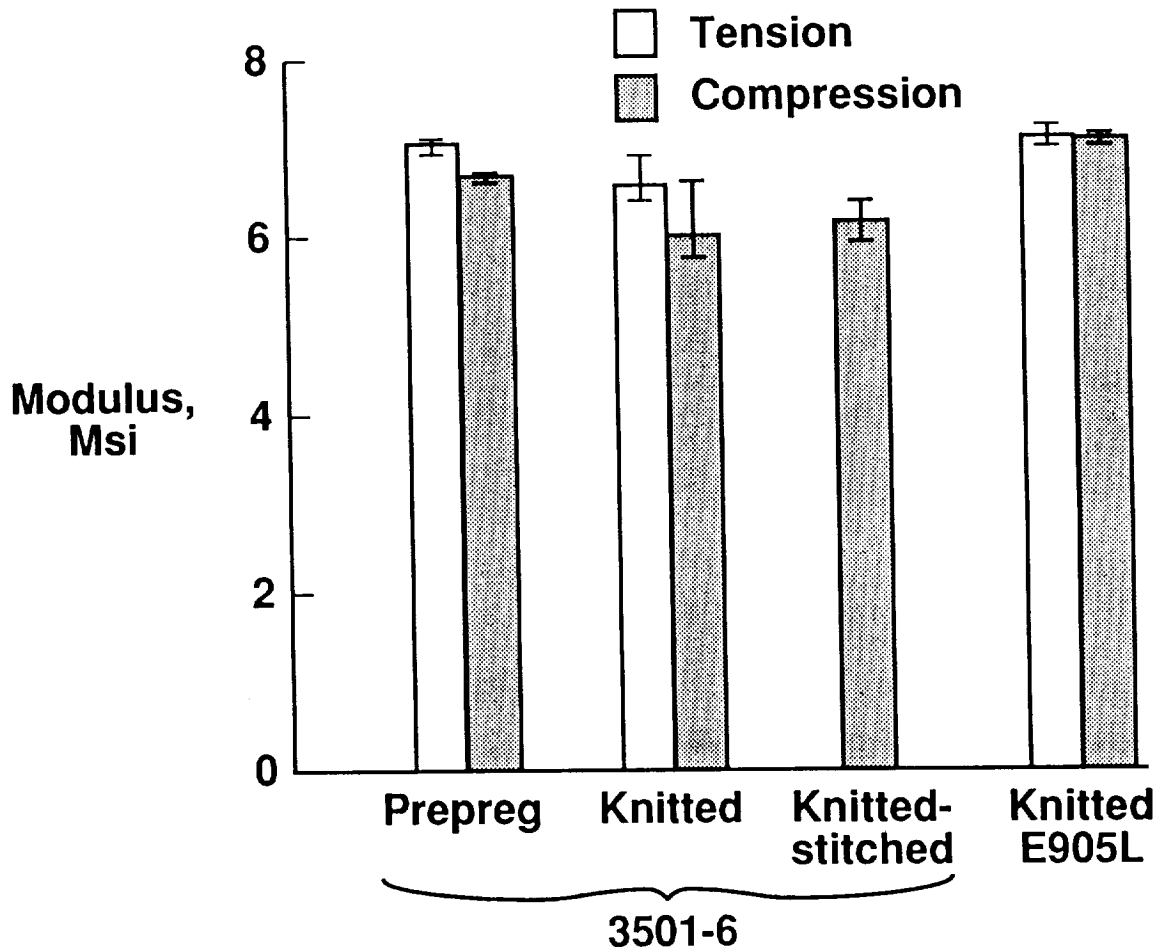
Figure 21

Tensile and compression modulus data are presented in figure 21 for the Milliken fabric. The tensile modulus is slightly higher than the compression modulus for all the materials indicated in the figure. The moduli for the 3501-6 knitted and knitted-stitched fabrics are slightly lower than the corresponding moduli for the prepreg tape laminates. The moduli for the E905L knitted fabric are equivalent to the prepreg tape moduli.

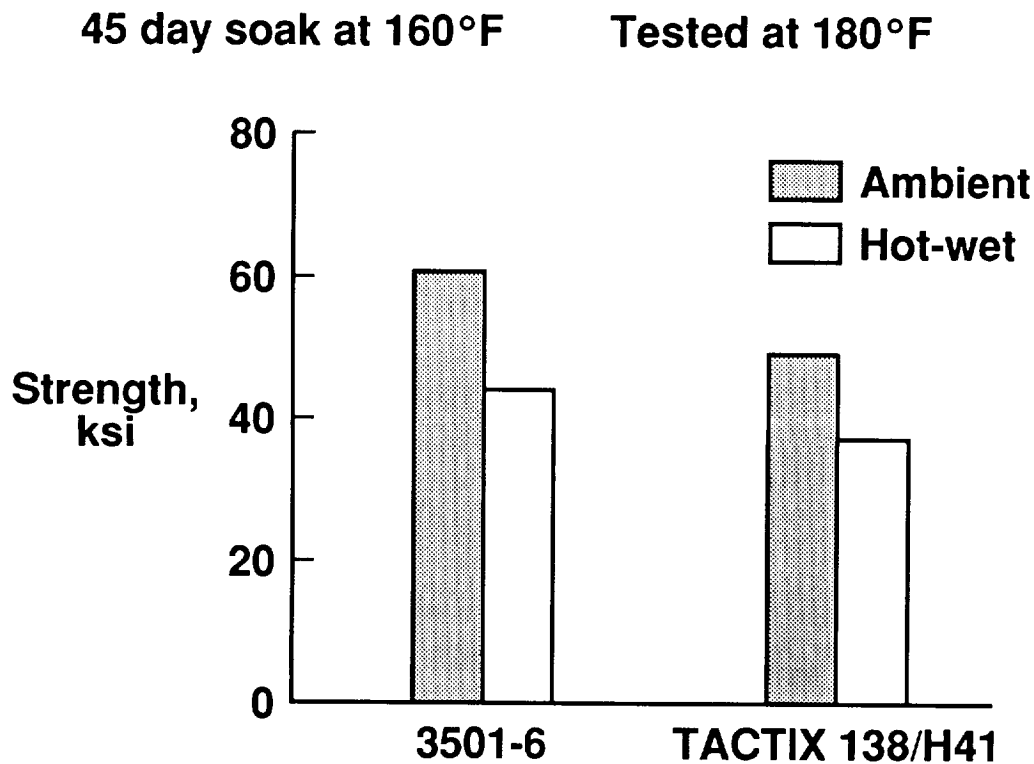
Figure 22

The effect of moisture and temperature on the compression strength of the Hexcel Hi-Tech knitted-stitched fabric is shown in figure 22 for the 3501-6 and Tactix 138/H41 resin systems. Ten coupons were taken from panels made with each resin. Five of each were tested at ambient conditions, and another five of each were conditioned and tested at elevated temperature. The compression coupons were soaked in a water bath at 160°F for 45 days to moisture condition the coupons. The 3501-6 coupons absorbed 1.1 percent moisture whereas the Tactix 138/H41 coupons absorbed only 0.6 percent moisture. After moisture conditioning, the coupons were tested at 180°F in an environmental chamber. The test results indicate that the compression strength of the 3501-6 material was reduced by 28 percent compared to the ambient compression strength. The compression strength of the Tactix 138/H41 material was reduced by 24 percent compared to ambient compression strength. As expected, the lower moisture absorption for the Tactix 138/H41 resin system resulted in a somewhat lower percentage reduction in compression strength. As shown in figure 22, the ambient compression strength of the Tactix 138/H41 resin system was about 20 percent lower than the ambient compression strength of the 3501-6 resin system.

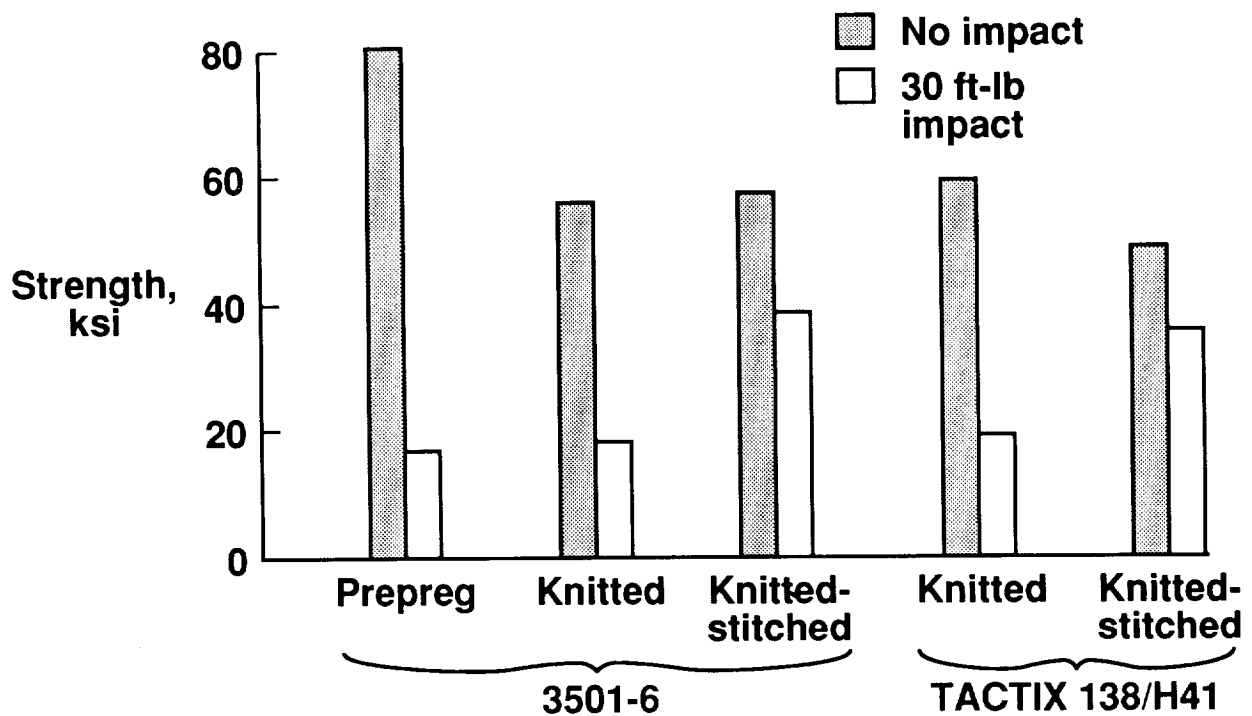
Figure 23

The effect of impact on the compression strength of the Hexcel Hi-Tech fabric is shown in figure 23. The knitted and knitted-stitched fabrics are compared to prepreg tape laminates with similar ply orientations. A 30 ft-lb impact reduced the compression strength of the 3501-6 prepreg laminate from 80 ksi to less than 20 ksi. Although the baseline strengths of the 3501-6 and Tactix 138/H41 knitted laminates were 20 ksi lower than the strength of the prepreg tape laminates, compression after impact strengths were slightly higher. Stitching the knitted fabrics resulted in over 100 percent increase in compression after impact strength compared to the prepreg tape laminates. Although the baseline compression strength of the Tactix 138/H41 knitted-stitched laminates was somewhat lower than the strength of the 3501-6 knitted-stitched laminate, the strength after impact was similar for the two resin systems.

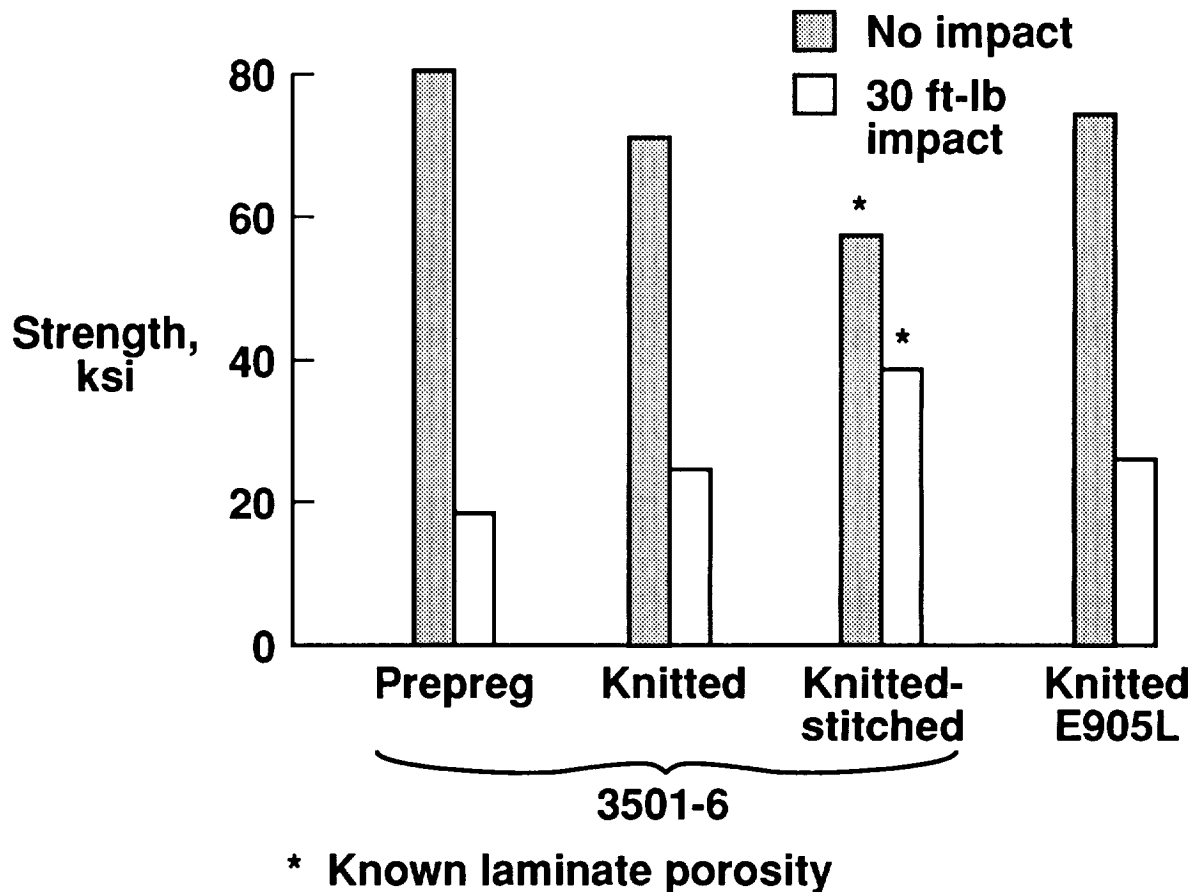
Figure 24

The effect of impact on the compression strength of Milliken fabric is shown in figure 24. As for the Hexcel prepreg tape laminates, a 30 ft-lb impact reduced the strength of the Milliken prepreg tape laminates from 80 ksi to less than 20 ksi. The knitted fabrics with the 3501-6 and E905L resin systems had a compression after impact strength of about 25 ksi. Only one Kevlar 29 stitched panel was fabricated and it had significant surface porosity and internal porosity. Even with the porosity, the knitted-stitched laminate had a compression after impact strength of almost 40 ksi. This result indicates the significant role that through-the-thickness reinforcement plays in improving the damage tolerance of composite materials.

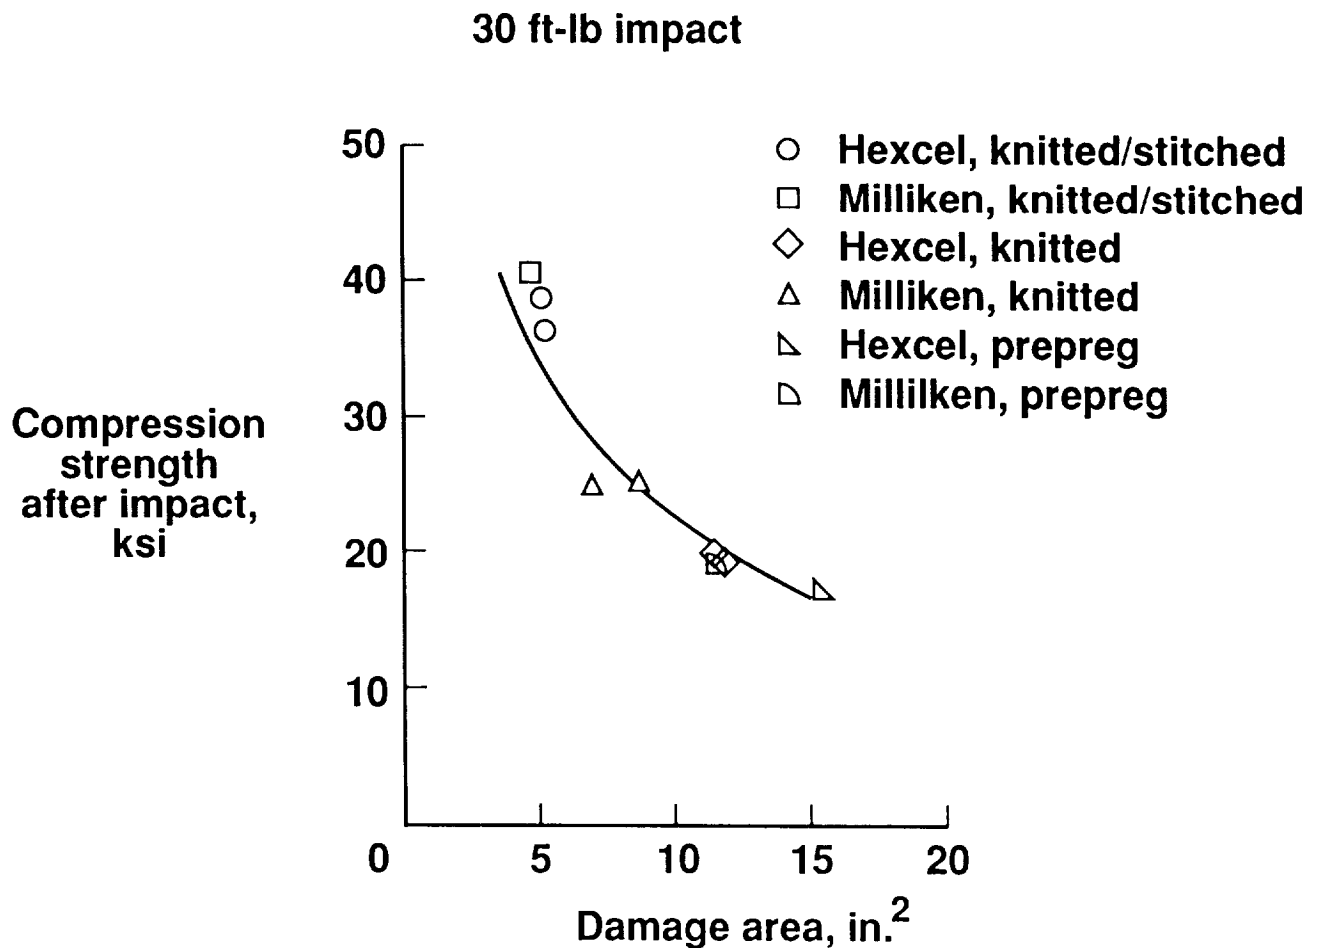
Figure 25

The effect of damage area on the compression strength of the Hexcel Hi-Tech and Milliken fabrics is shown in figure 25. The damage areas plotted are a result of a 30 ft-lb impact and were detected by ultrasonics and were calculated by computer image analysis. The prepreg tape laminates and the knitted Hexcel Hi-Tech laminates had the most damage and the lowest strength. The least amount of damage, approximately 5 in<sup>2</sup>, was sustained by the Hexcel Hi-Tech and Milliken knitted-stitched fabrics. The Milliken knitted-stitched fabric achieved the highest strength, about 40 ksi. The somewhat higher strength and lower damage area of knitted, unstitched Milliken material compared to the knitted, unstitched Hexcel material may be due to three parameters: higher weight knitting yarn, tighter knit spacing and more knitted plies per subgroup.

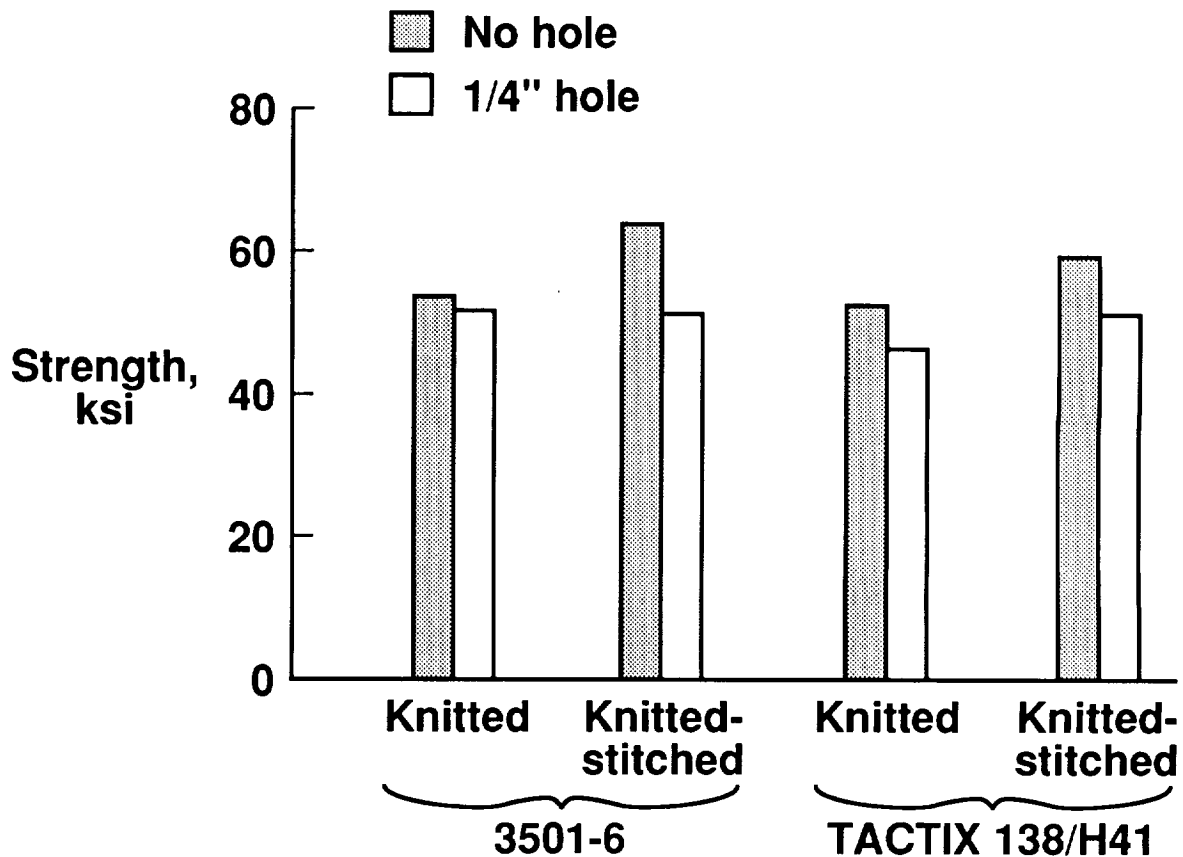
Figure 26

The effect of a 1/4-inch diameter hole on the tensile strength of the Hexcel Hi-Tech fabric is shown in figure 26. The reduction in tensile strength due to the hole is less than would be expected based on loss in cross-sectional area. This result may indicate grip effects on the unnotched tensile strength. The open hole tensile strengths for the 3501-6 and Tactix 138/H41 resin systems are similar to the strengths reported in reference 4 for three AS-4/epoxy laminated tape composite material systems.

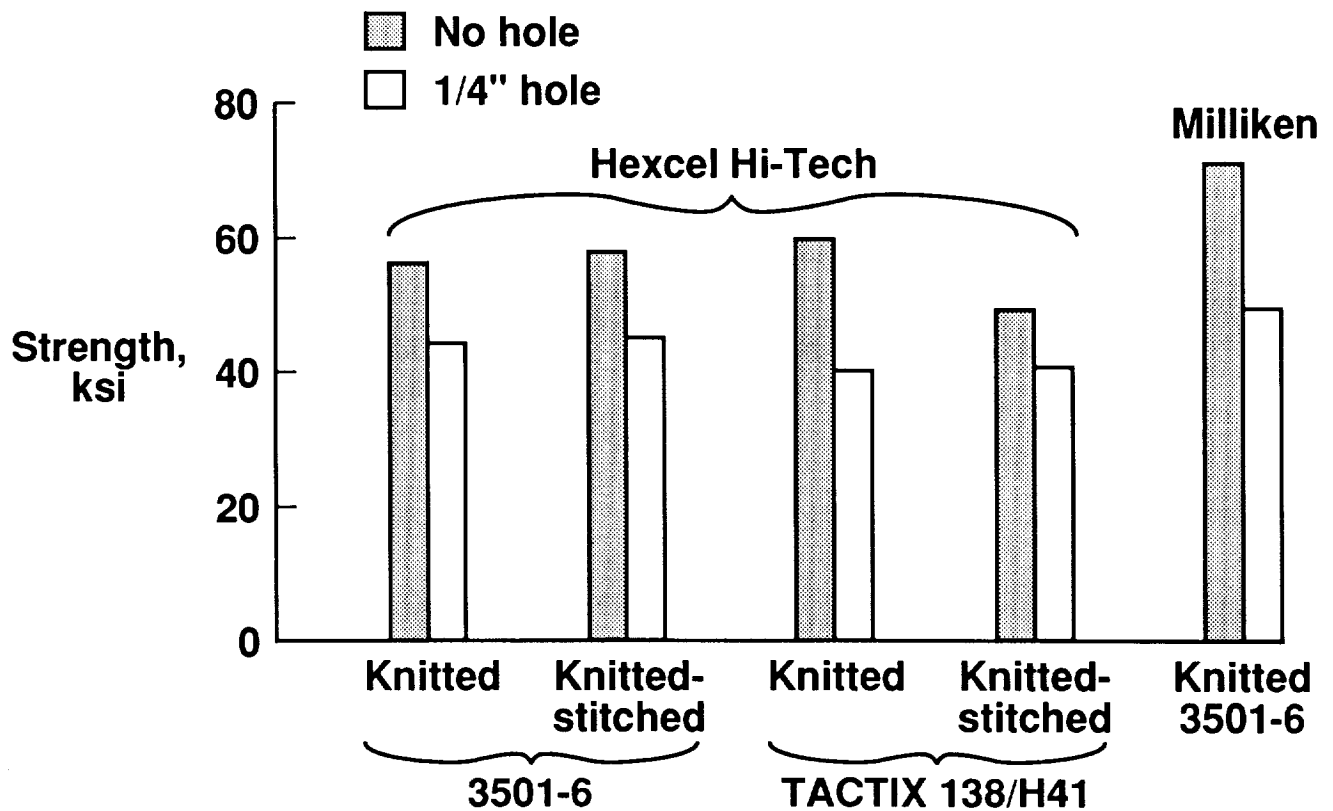
Figure 27

The effect of a 1/4-inch diameter hole on the compression strength of the Hexcel Hi-Tech and Milliken fabrics is shown in figure 27. Although the open hole compression specimens are twice as wide as the open hole tension specimens, the strength reduction in compression was significantly more. The open hole compression strengths for the fabrics indicated in figure 27 ranged from 40 to 50 ksi. These results are in agreement with laminated tape data presented in reference 4 for three AS-4/epoxy composite material systems. The Milliken fabric performed slightly better than the Hexcel Hi-Tech fabric.

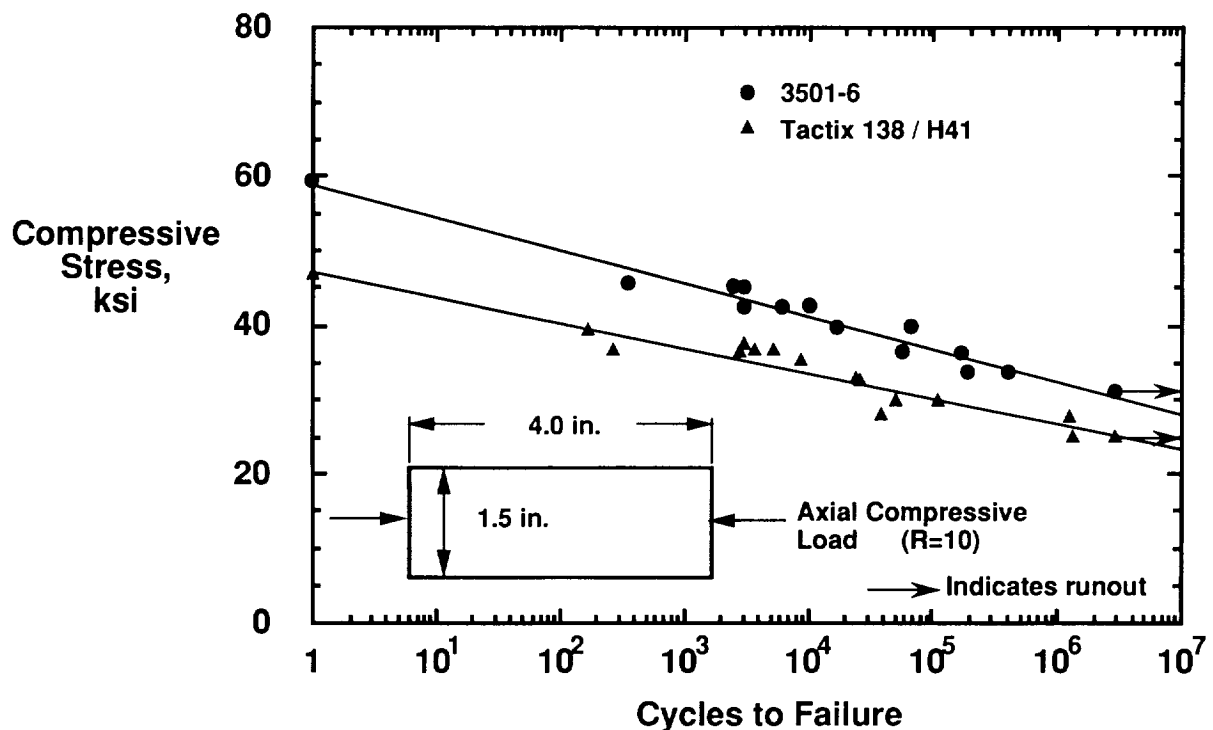
Figure 28

Constant amplitude compression-compression fatigue tests were conducted on the Hexcel Hi-Tech knitted-stitched fabric and the results are shown in figure 28. Hercules AS-4 fiber with both Hercules 3501-6 and Dow Tactix 138/H41 resins were used to fabricate laminates. The test specimens were 1.5 inches wide by 4.0 inches long with a nominal thickness of 0.25-inch. The fatigue tests were run at room temperature in a closed-loop servo-hydraulic test machine at a frequency of 10 Hz. All specimens were tested with an R-ratio (minimum load/maximum load) of 10.

The tests were conducted by subjecting the test specimens to selected stress levels and cycling the specimens until failure. The static compression strength (one cycle to failure) of the 3501-6 specimens was approximately 28-percent higher than the static strength of the Tactix 138/H41 specimens. After the initial knockdown in strength in the Tactix 138/H41 material, the two materials had similar S-N curves. Due to the initial strength knockdown, the 3501-6 specimens had longer fatigue lives for a given stress level. Observation of selected specimens during testing indicated that damage initiated earlier in the 3501-6 specimens; however, the damage did not grow as fast compared to the Tactix 138/H41 specimens. Tactix 138/H41 is a softer (lower modulus) resin, which may account for this behavior.
